APOLLO 9 MISSION REPORT

MAY 1969

Mission Evaluation Team

George M. Low
Manager, Apollo Spacecraft Program

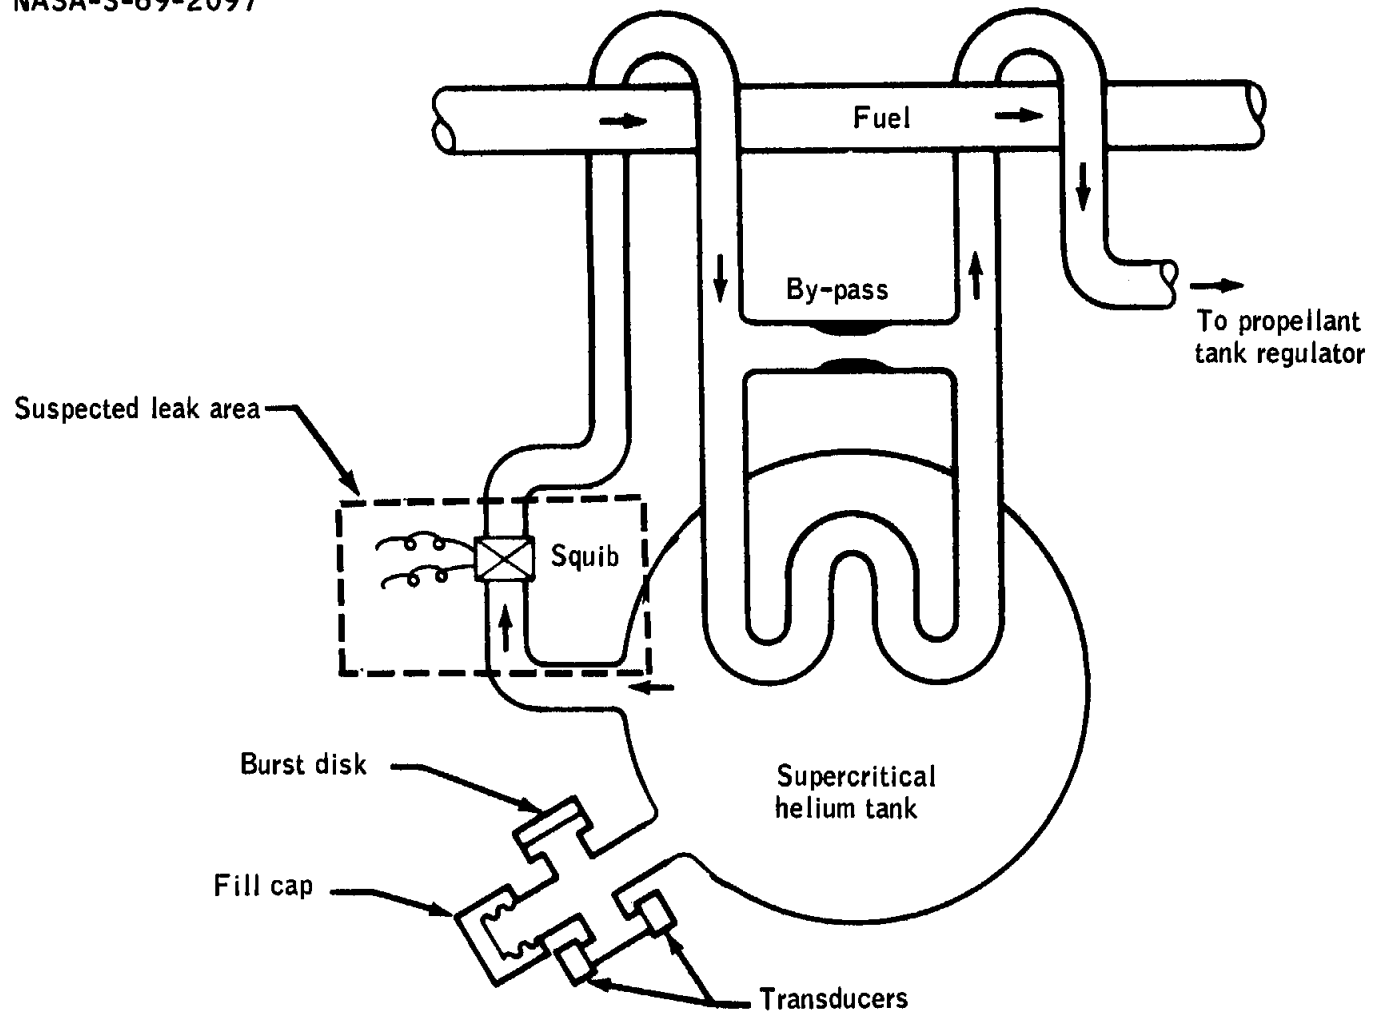
Figure 17-19.- Supercritical helium pressure suspected leak area.

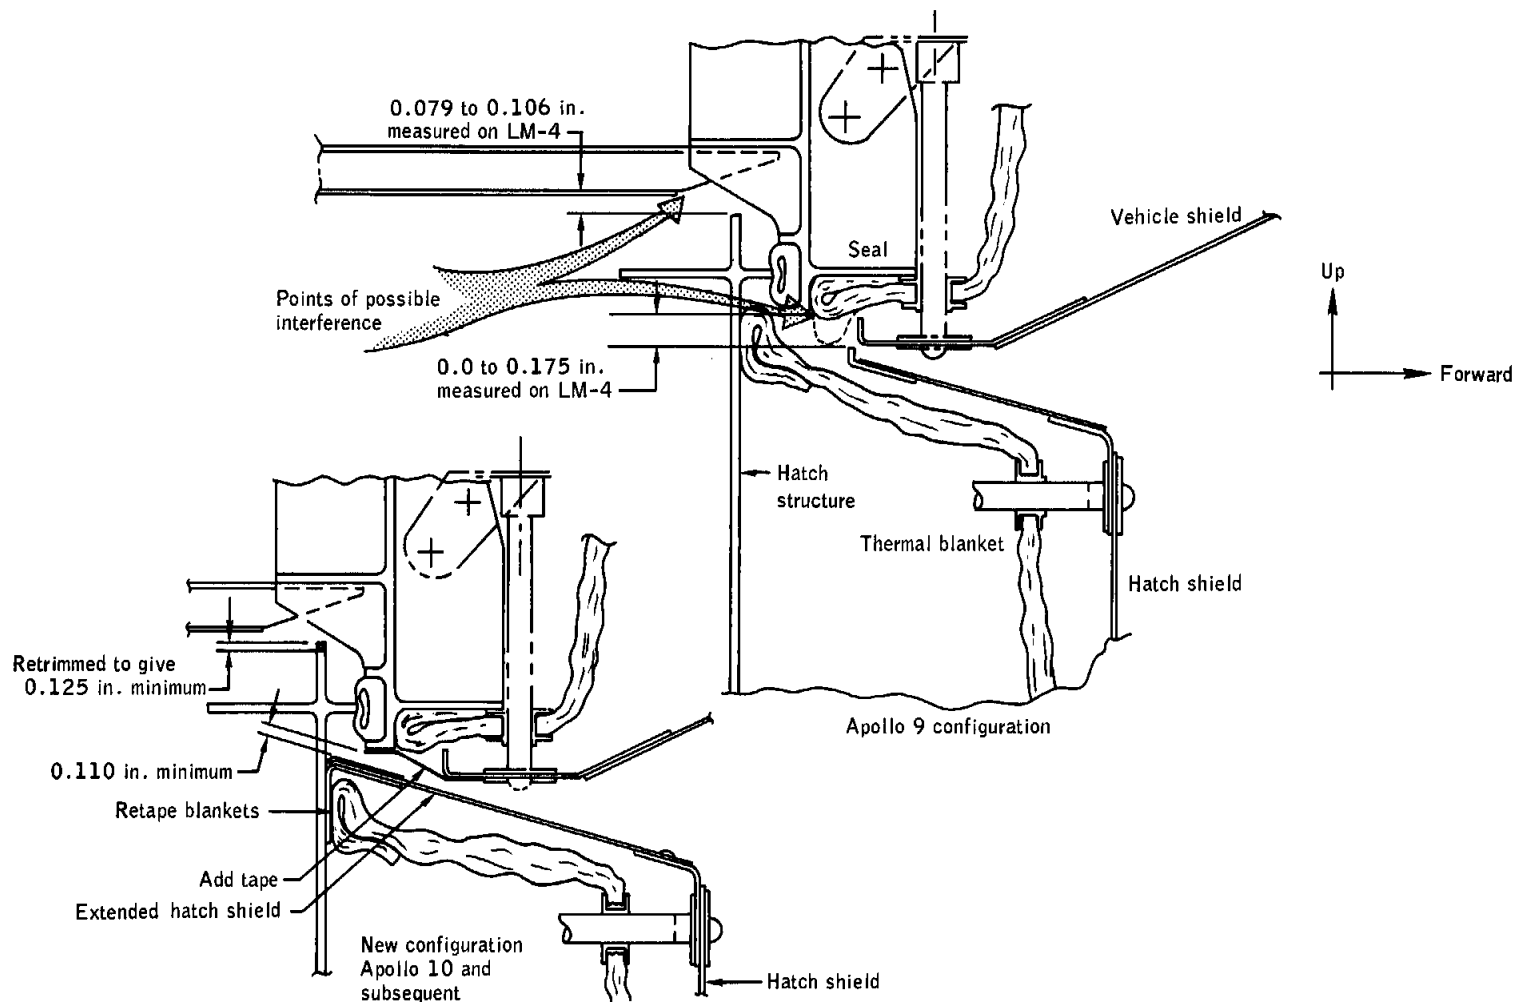
Figure 17-22.- Potential hatch interferences.
